Cessna Cowling Mounts

March 14, 2024 Rev9

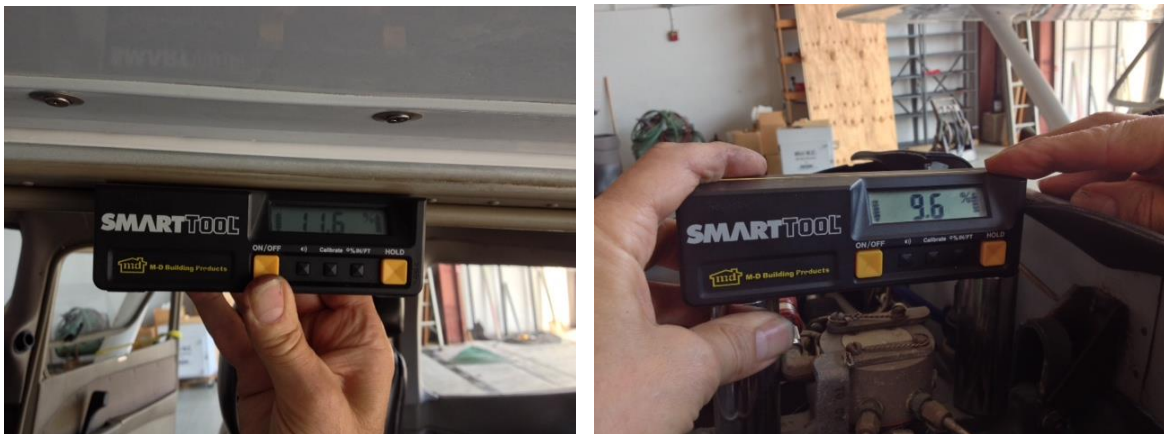
Airframe level (measured at door post) was 11.6 degrees nose up. The engine level was 9.6 nose up. This indicates that the engine is sagging or has an inclination of 2.0 degrees down.

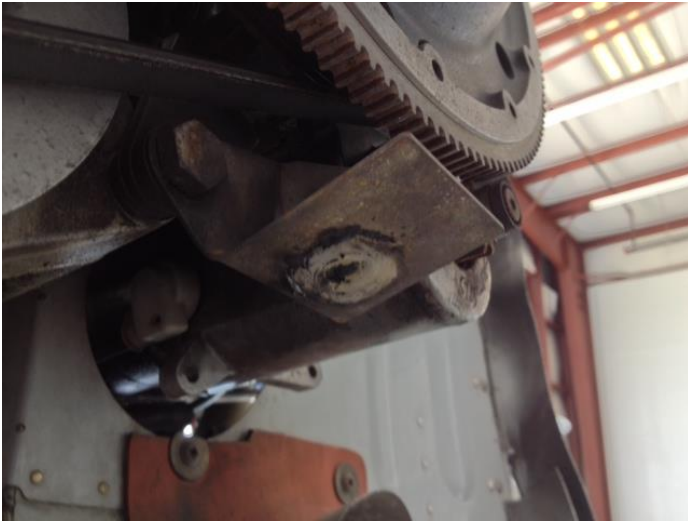
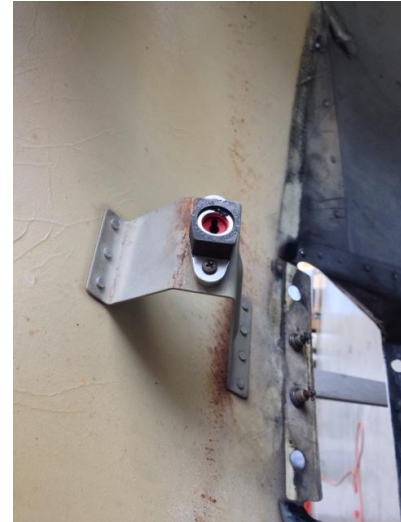
The snubber plate mounted to the O360 engine. Note the wear marks from a worn out snubber. A new snubber plate mounted to the forward nose of the cowling. Note: earlier C172 cowlings had landing light fixtures in lieu of the snubber bracket.

If your aircraft seems to have more than its share of cowling mount failures, check the condition of the cowling snubber. If it is resting on the engine bracket with the engine not running, check that the snubber is not excessively shimmed. Reduce the shims to remove some of the shear loads placed on the cowling mounts.

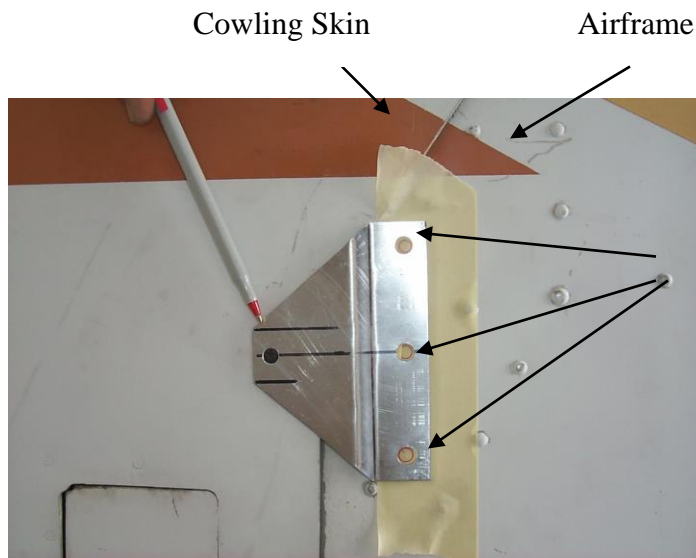
The Skybolt SK203-TEM1 - Prior to removing the cowling, locate each fastener center using this template. Marking the three holes onto masking tape as shown establishes the cowling hole location with the cowling removed.

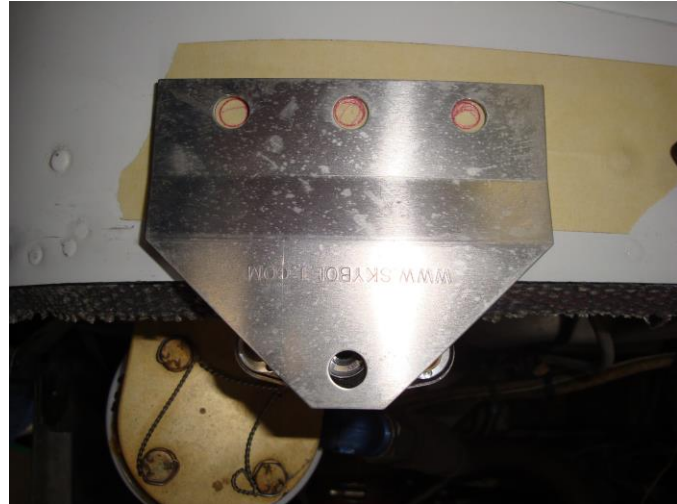
This example is all too common. The fastener, with some coaxing, will lock but the mount is pre-stressed before adding additional stress by the engine striking the cowling. If left alone, mounts are going to fail.

With Skybolt SK2003-AW Camwashers installed, simply “dialing” the mount to agree with the corresponding hole (centered), we have neutralized static stress. We can also “shift” the cowling in all axis to match paint lines, but most important, prevent the engine from hitting the cowling, particularly as a result of a firm landing. There are other factors, but the engine striking the cowling is the most notorious for failures.

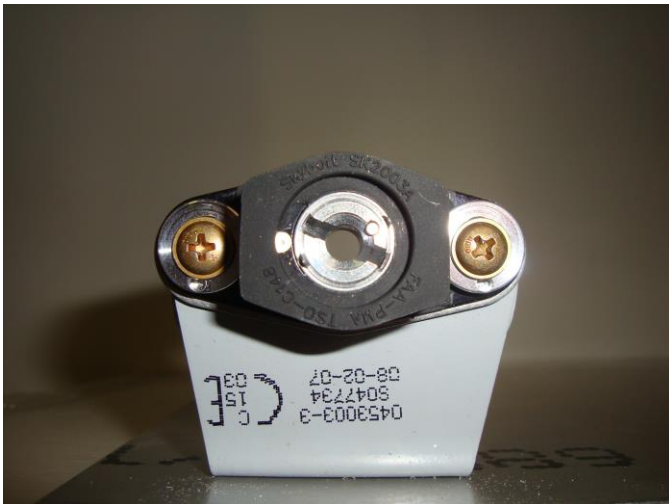
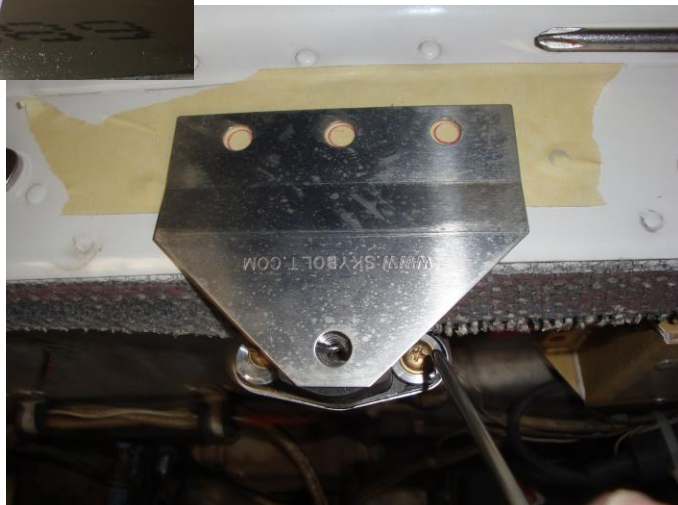
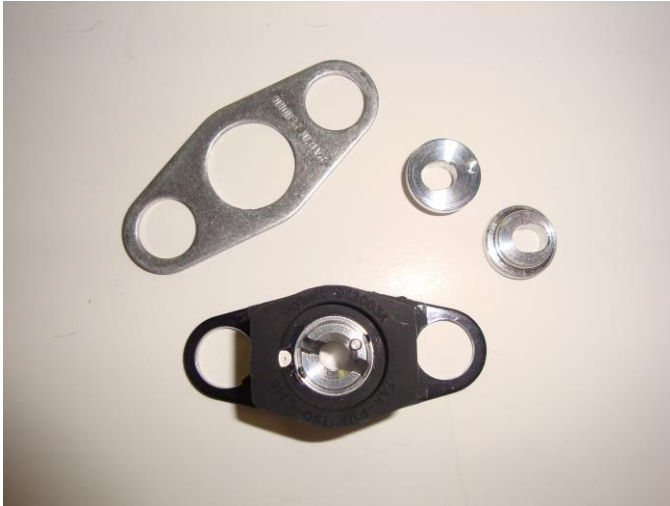
Example of Skybolt SK2003 Mount drilled to accept the SK2003-AW Camwasher set. (Skybolt SK203 Instructions suggest a simple way to successfully drill these holes). Note: Drilled shim is only required for the -50ADJ mounts and are predrilled in SK2003-AW5 SET.

By rotating the Camwashers, this mount can be relocated in all axis by a considerable amount without altering the mounting brackets or relocating the brackets (as suggested by the Cessna

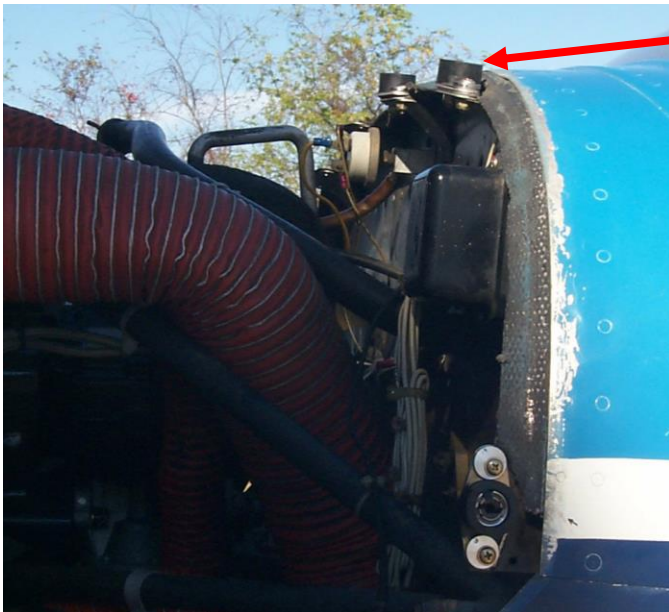
Here is another common observation. Mounts are angled excessively up or down. With the mount removed, the mounting bracket can be “aligned” to agree with the cowling slope by bending the 2-piece bracket, clamp, and re-drill the mounting holes. This may (probably will) relocate the mount center relative to the cowling hole. Using the SK2003-AW Camwashers, this mount is now faced (angled properly) with the cowling and centered to relieve static load.
